**CORROSION
PREVENTION &
REMOVAL
SYSTEMS**

ENAMX CPDS APPLICATION CASE STUDIES

PREFACE

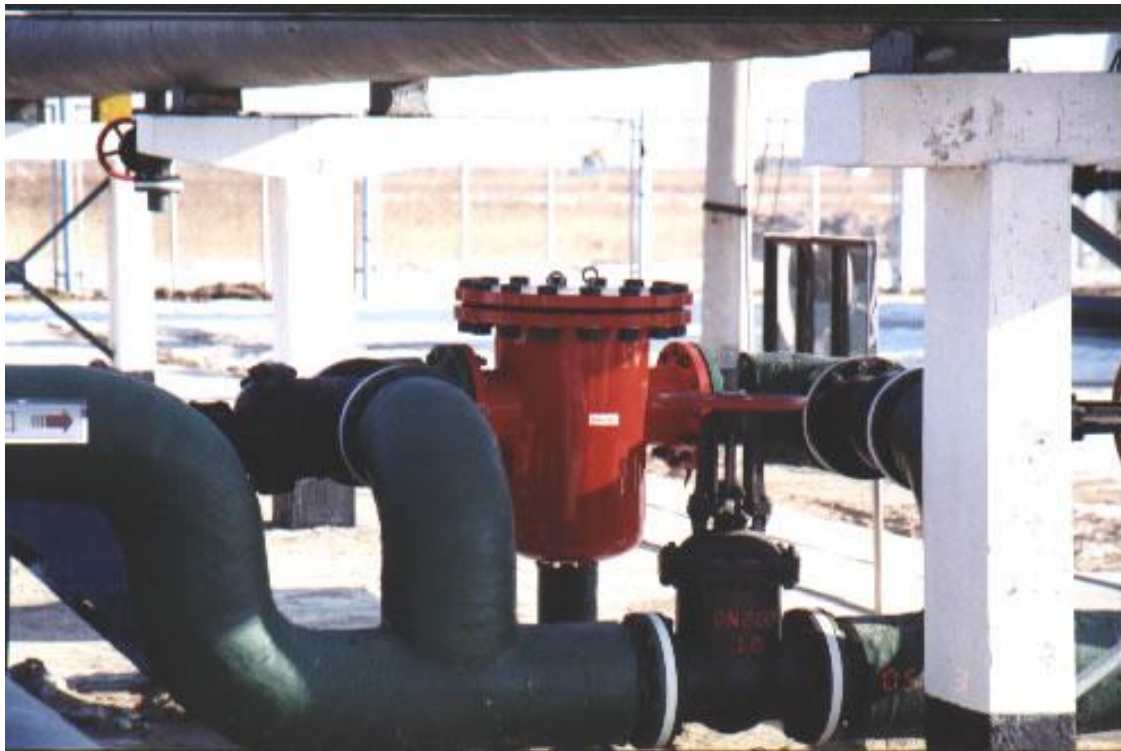
- Before the installation, the scale thickness at the outlet was 2.5cm hard scale, it was reduced to 0.8 mm when inspected on June 20, 2005, and reduced to 0.4 cm on Sept. 23, 2005.
- Before the installation, the scale thickness at the inlet was 4mm, there was no more scale buildup on June 20 and Sept 23, 2005 for inspection.

Location	Before Installation		7 Months After	9 Months After	7 months	9 months		
Heater inlet	4 mm	Very hard	0	Crispy	0	No	-4 mm	-4 mm
Heater tubes	7 mm	Very hard	2.5	Crispy	1	Crispy soft	-4.5 mm	-6 mm
Metering valve	7 mm	Very hard	1.5	Crispy	0		-5.5 mm

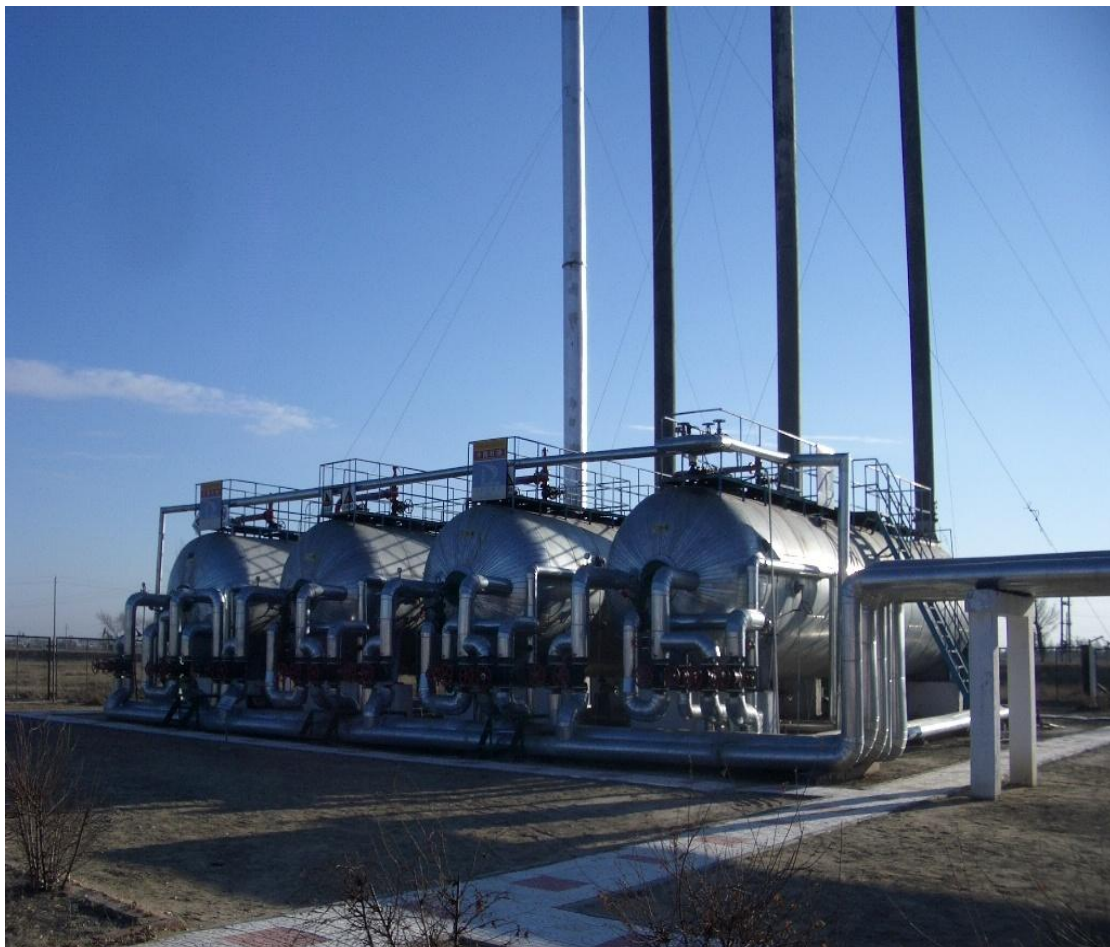
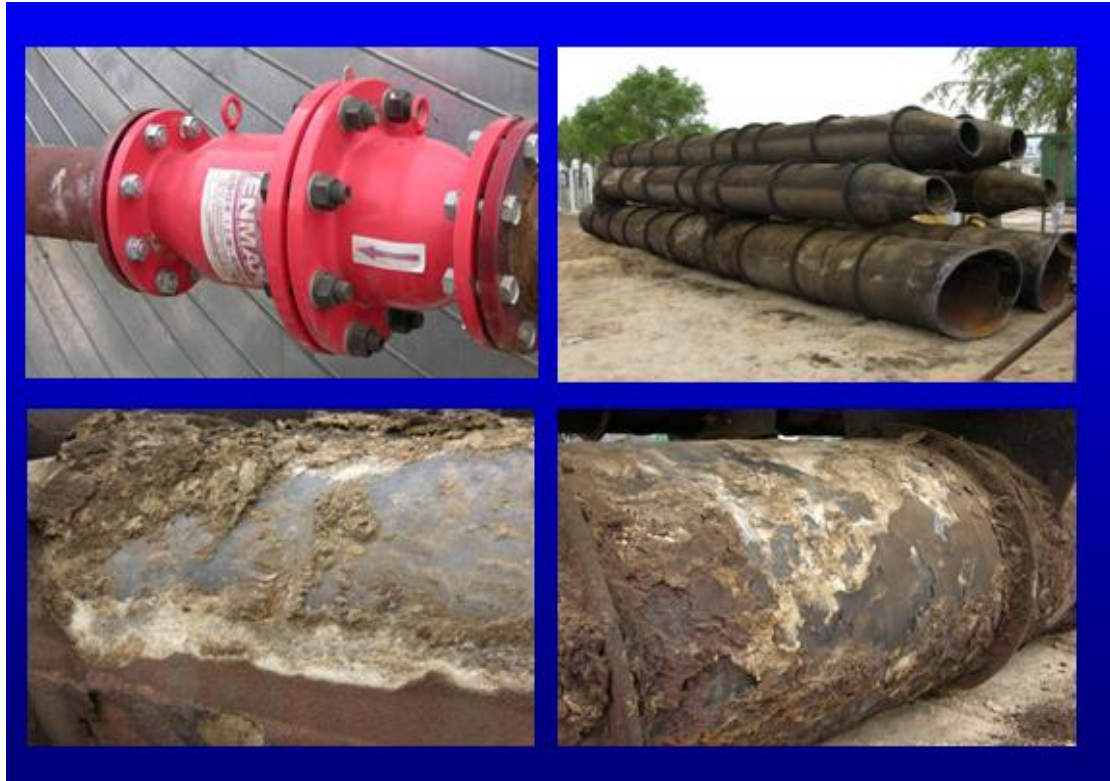
- A six month test was done on Enmax CPRS surface units by Daqing Oilfield Designing Institute and Daqing No. 1 Production Company for polymer fluid scale prevention and removal performance evaluation.
- The scale thickness in the heaters was about 20 mm, some scale are old scale deposits due to uncompleted cleaning jobs.
- Four surface units were installed on Jan. 5, 2006 at the inlets of four heaters at Transfer Station No. 201 of Daqing No. 1 Production Company.
- Chemical additives were stopped on March 17.
- Six months after the installation, the tools were inspected on June 14, 2006, and the tubes of No. 2 heater were pulled out for inspection.

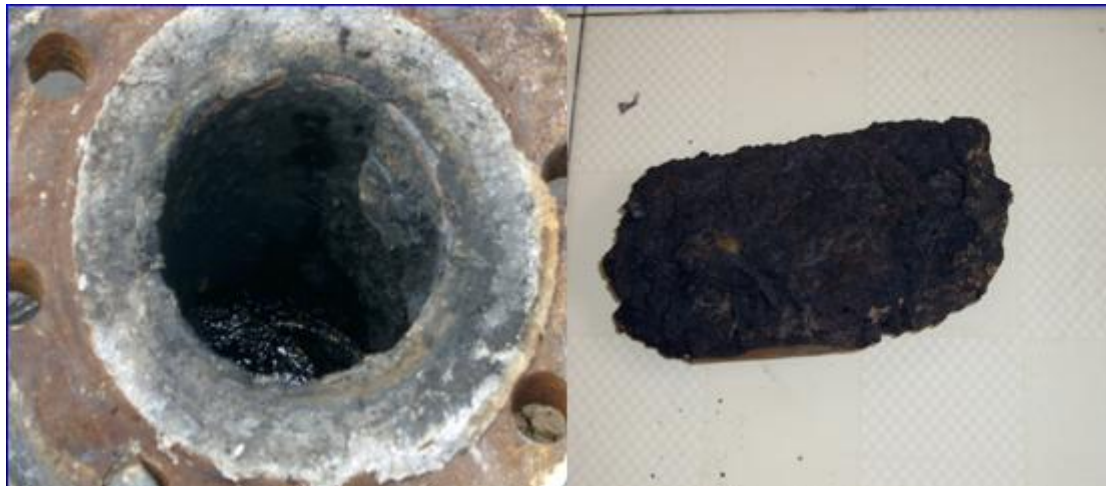
Very hard and consolidated scale

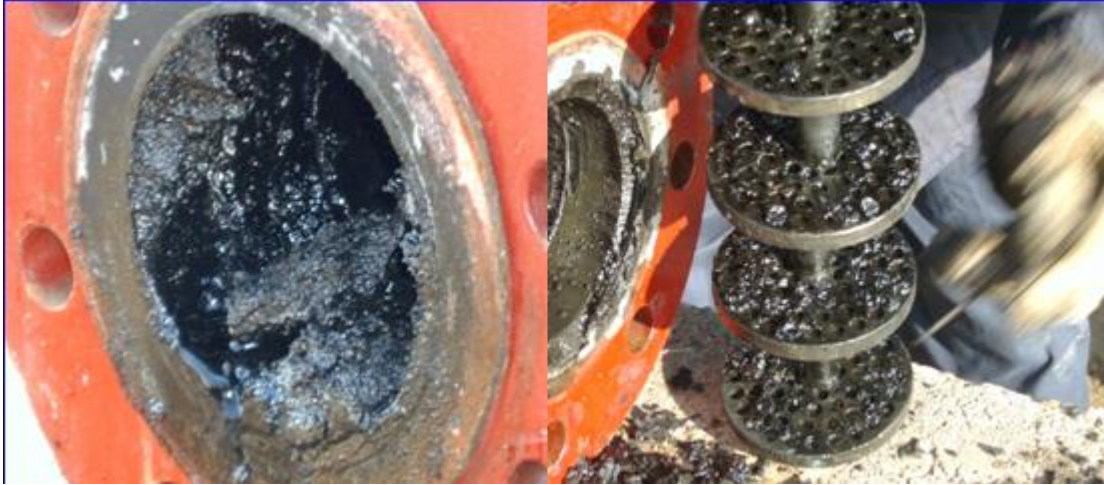
**Three months After installation on August 28, 2007:**

The scale became softer as slurry and it can be scraped off with hands, and there was no new deposit noticed inside the flowline.

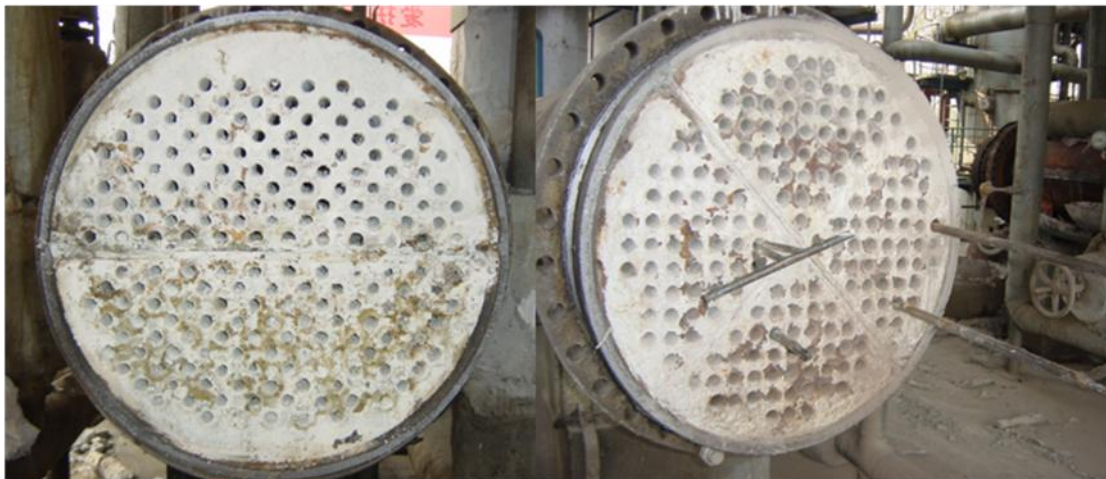
April, 15, 2005, heat exchangers being cleaned

Inlet

Outlet

In August, 2005, Enmax CPRS surface units were installed. On Dec., 8, 2005, 4 months after the installation, the heater exchanger was inspected, and it was found that there was not any new scale buildup and the uncleaned scale disappeared.

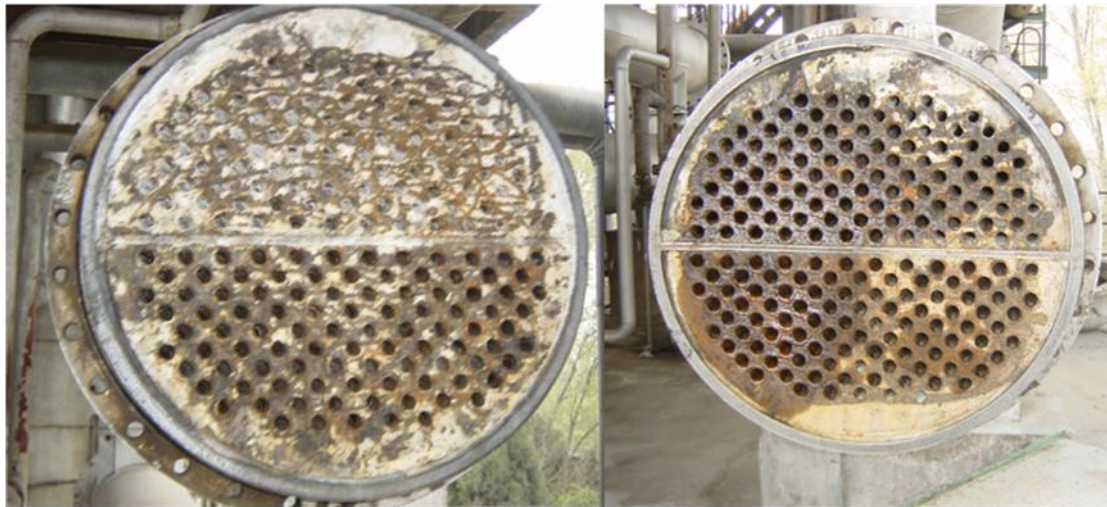
Heat exchangers after being cleaned

Inlet

Outlet

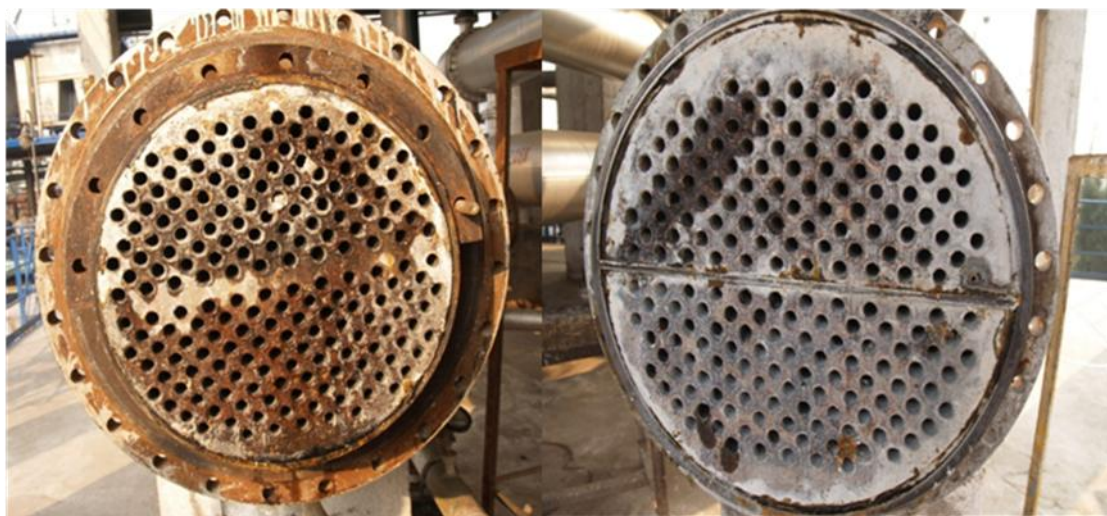
Four months after the installation

Inlet

Outlet

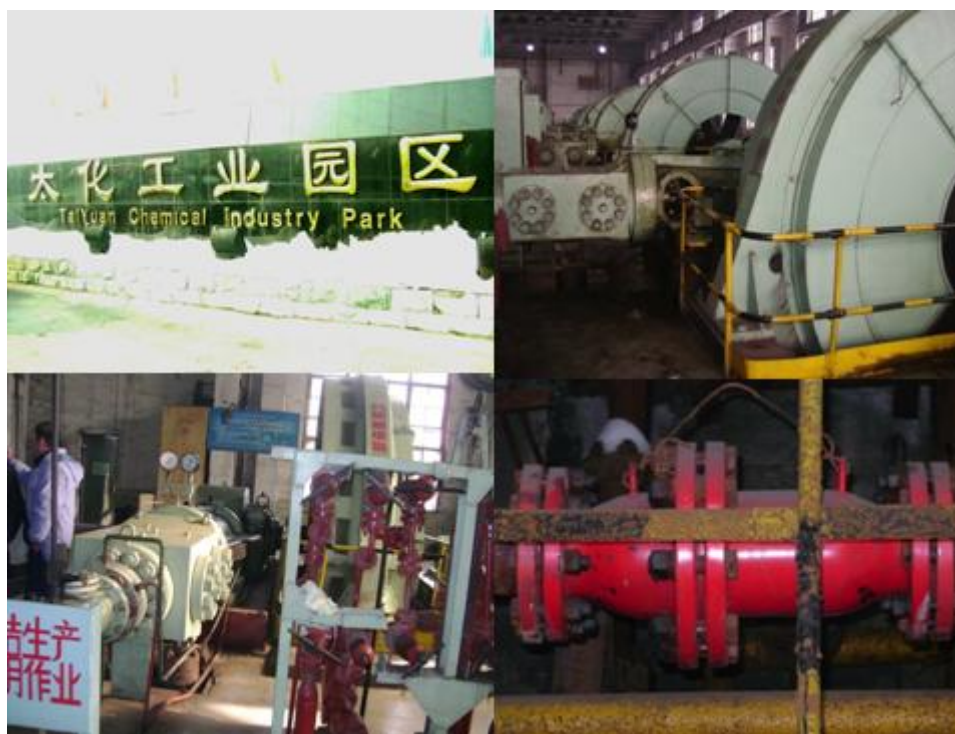
Location: Cooling Circuits of ammonia compressor

- The cooling water used was untreated water from the water well.
- Serious scale problems reduced the heat exchanging efficiency.
- Periodically the cooling circuits have to be cleaned with acids or replaced with new pipes.

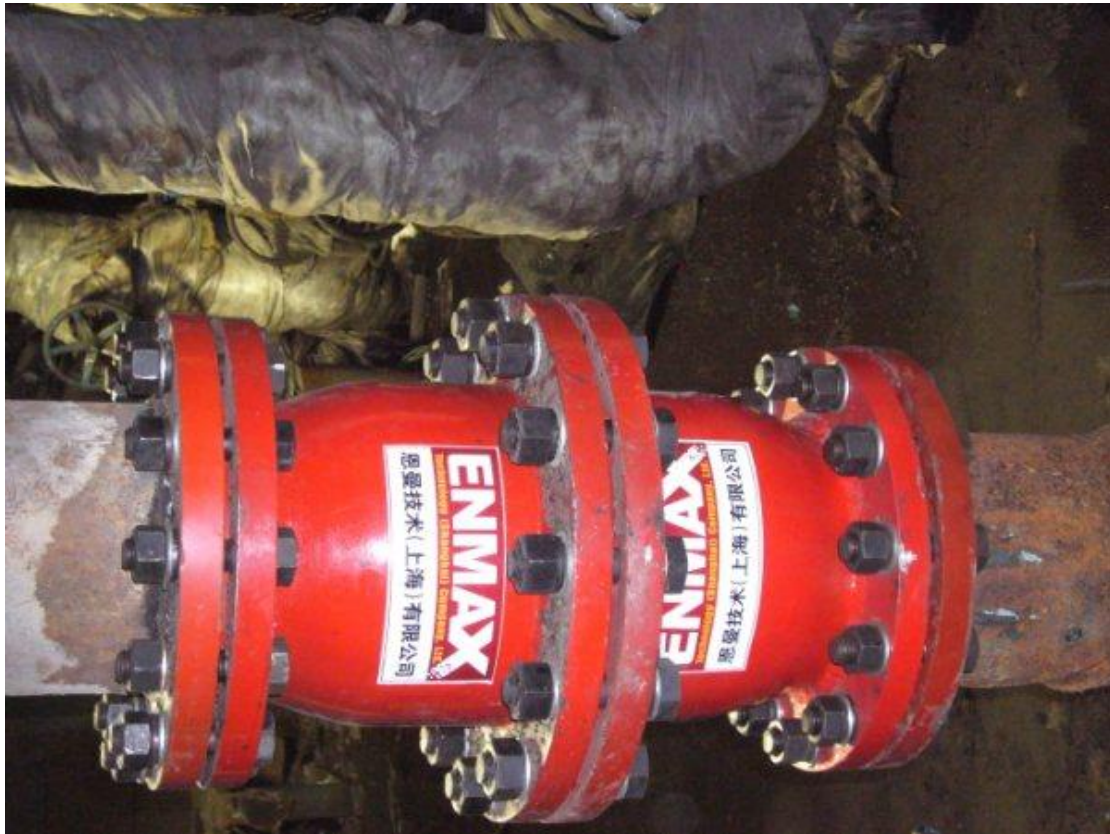
Location: Cooling system of #4 and #5 conicaster

- High hardness of cooling water
- Serious scale buildup on recirculation manifold and water nozzles, and nozzles were often fully plugged off by scale.

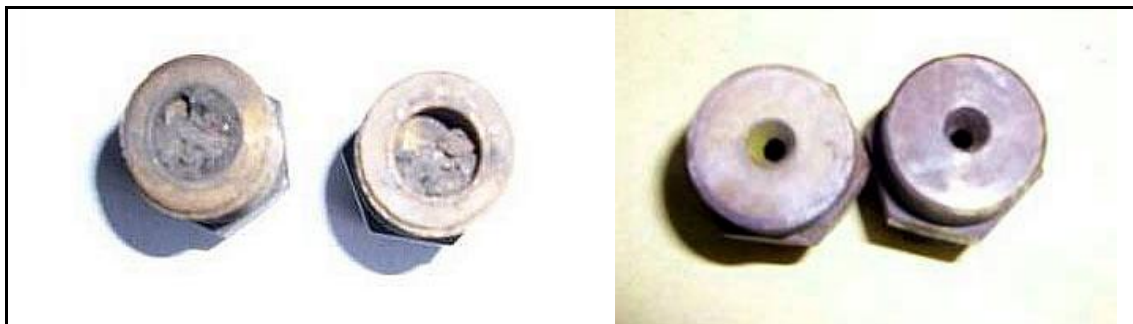
Before installtion of CPRS**After installation of CPRS**

- A 8"x10" CPRS unit was installed in #4 conticaster cooling circuit on November 8th, 2009.
- A 12"x12" CPRS unit was installed in #6 Conticaster cooling circuit on December 21st, 2009.
- The inspection after 3-month installation proved that the recirculation manifold and nozzle scale issues have been solved, which assured the normal operation performance of conticasters and the quality of the steel products.

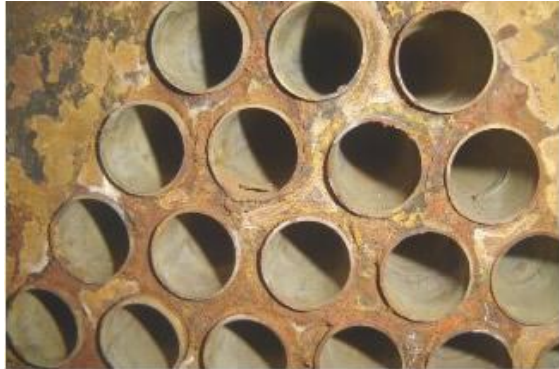
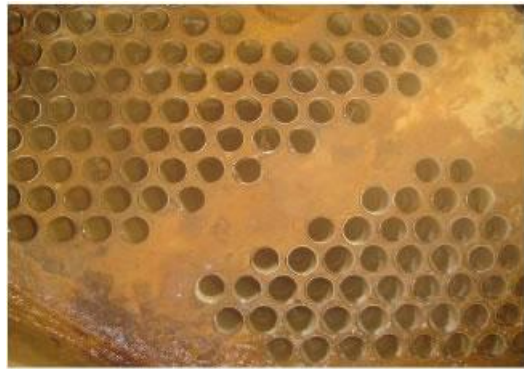
September 20. 2010, after the cleaning and before the installation

- The tubes had serious scales buildup and plugging-offs before the installation and there was no scale deposit after the installation.
- Before the installation, inside the inlet door, there were a lot of clay and rust scales, which were hard to clean. The inspection after the installation indicated that some of the old scales are gone and some became loose.

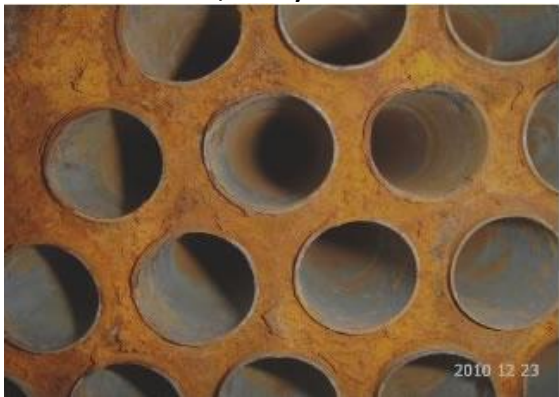
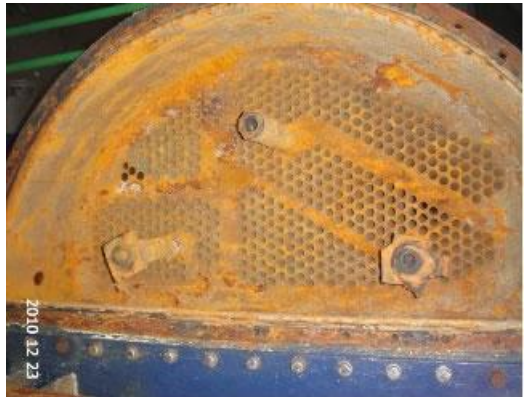
December 23. 2010, 75 days after the installation

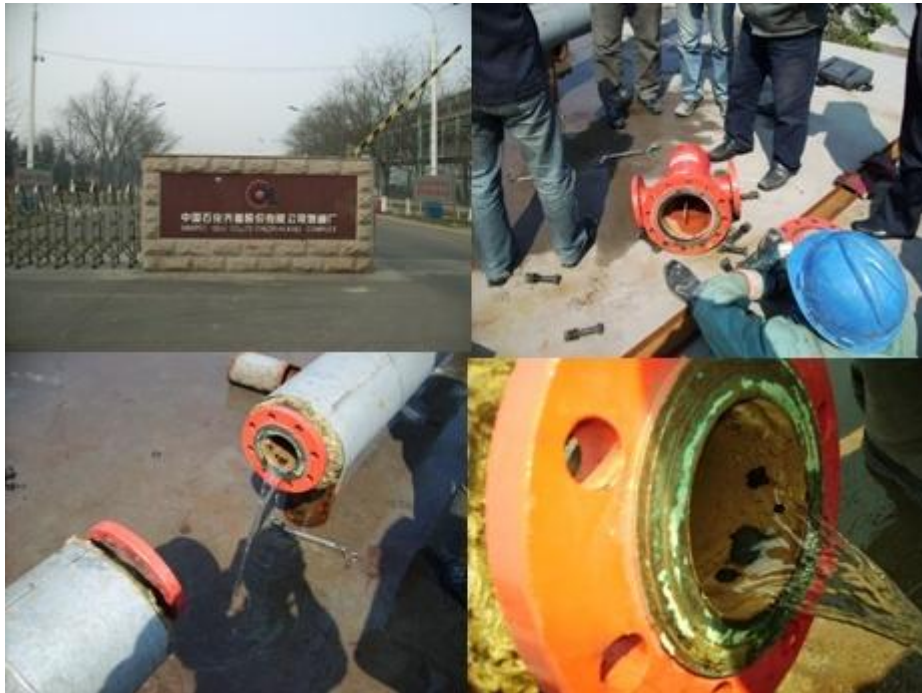
- The cooling system had very serious scaling problems, with a thickness of 20 mm scale built up inside of the cooling circuit.
- Chemicals and other scale inhibiting methods were tried without any success.

- A set of Enmax CPRS was selected for performance test, and it was installed in January, 2008 and opened for inspection after three months.
- The inspection proved that there was no new scale buildup at all and the old scale was reduced to 1 mm, which is very loose and soft and can be removed with hands.

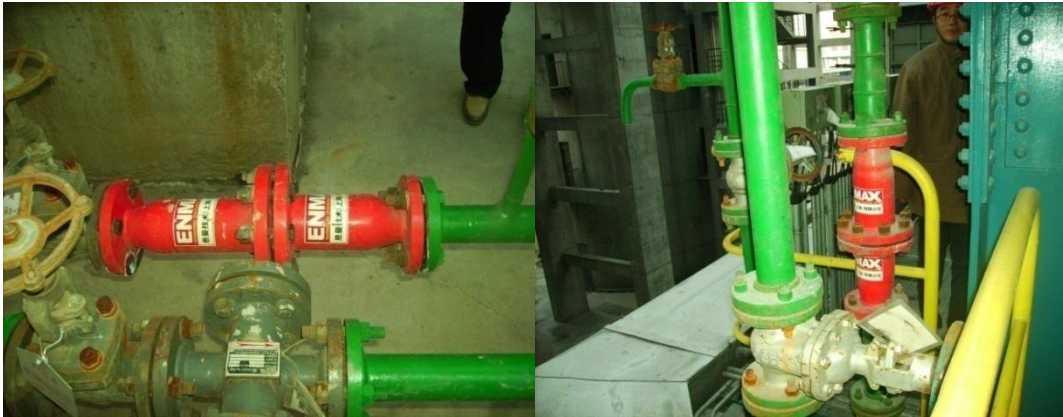
Tianjin Petrochemical Plant is setting up an ethylene plant with a capacity of 1 million tons per year. Enmax CPRS was approved by Sinopec Ningbo Designing Institute to be used for scale prevention. Here are the two pictures showing the installations.

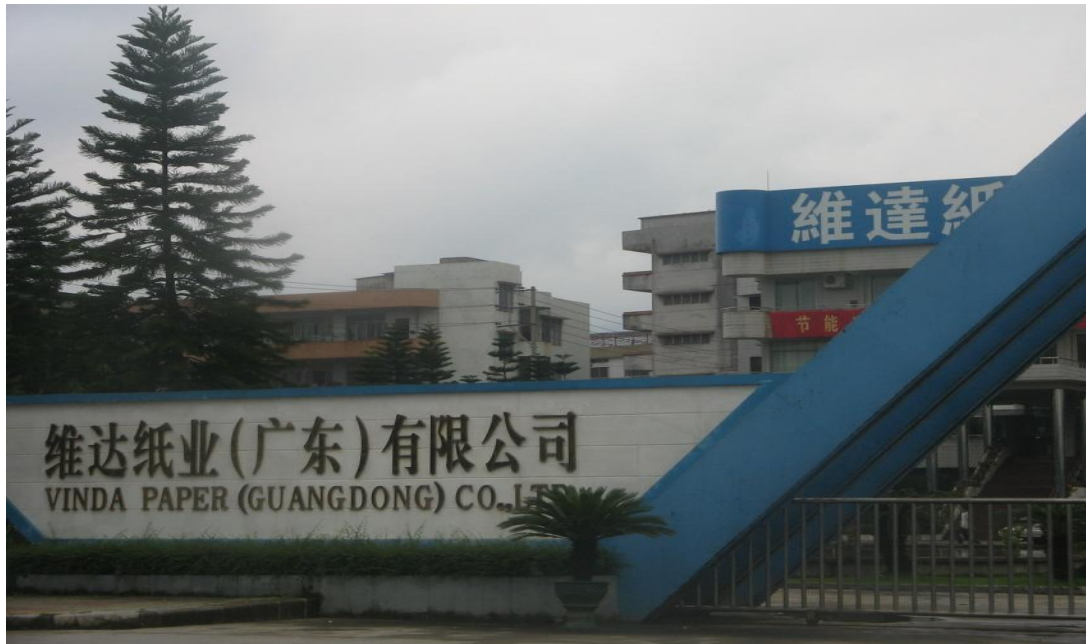
Location: Water ring vacuum pump

- The water ring vacuum pumps had serious scale problems.
- Chemical scale cleanings were required every year.
- The pump cannot be re-started smoothly after shutting down.

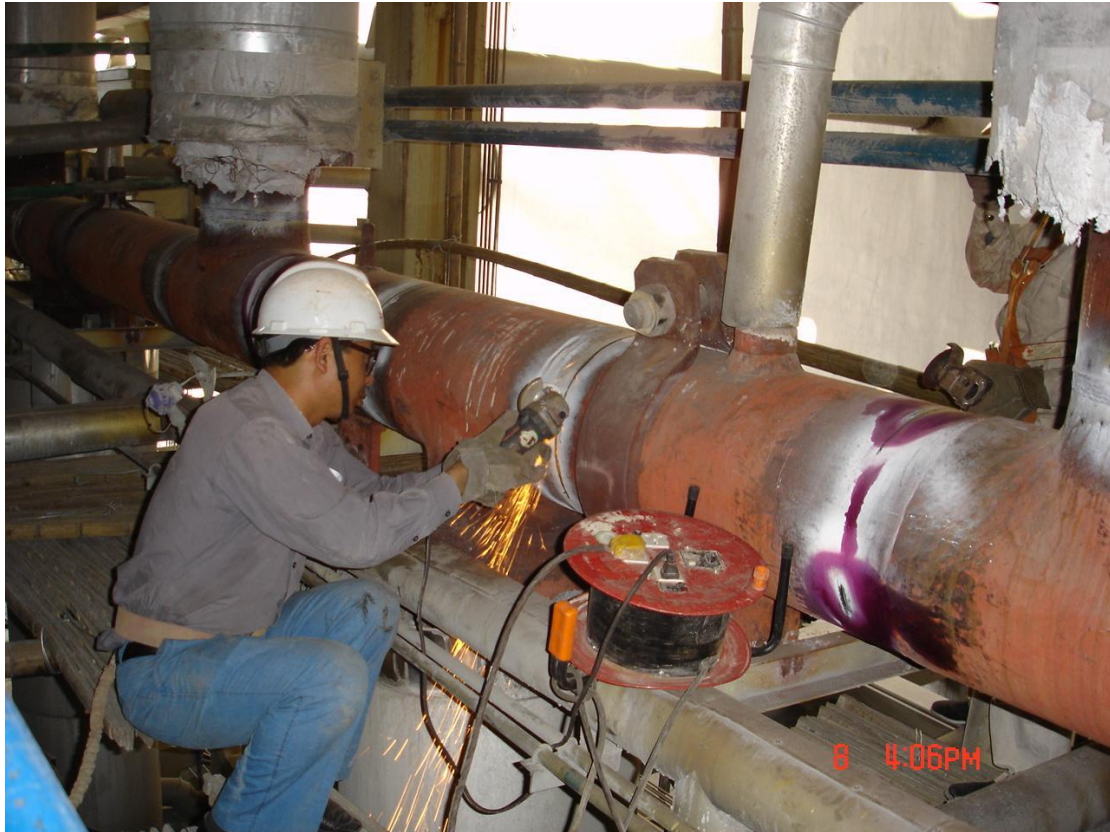
The vacuum utilizes industrial water of high hardness as working media, thereby resulting in serious scale problems and reduced the vacuum pump efficiency.

- A 2"x3" CPRS unit was installed in October, 2009 in the working circuit of Vacuum pump #A.
- The CPRS unit has been successful, and the scale has obviously been reduced.
- The scale, which the high pressure jetting could not remove and had to be removed with steel brushes, can be flushed away by jetting easily.
- The cleaning time reduced to less than one day from two days.
- The layer of old scale become thinner and soft, partially came off.
- Vacuum pump current reduced around 2 amps.

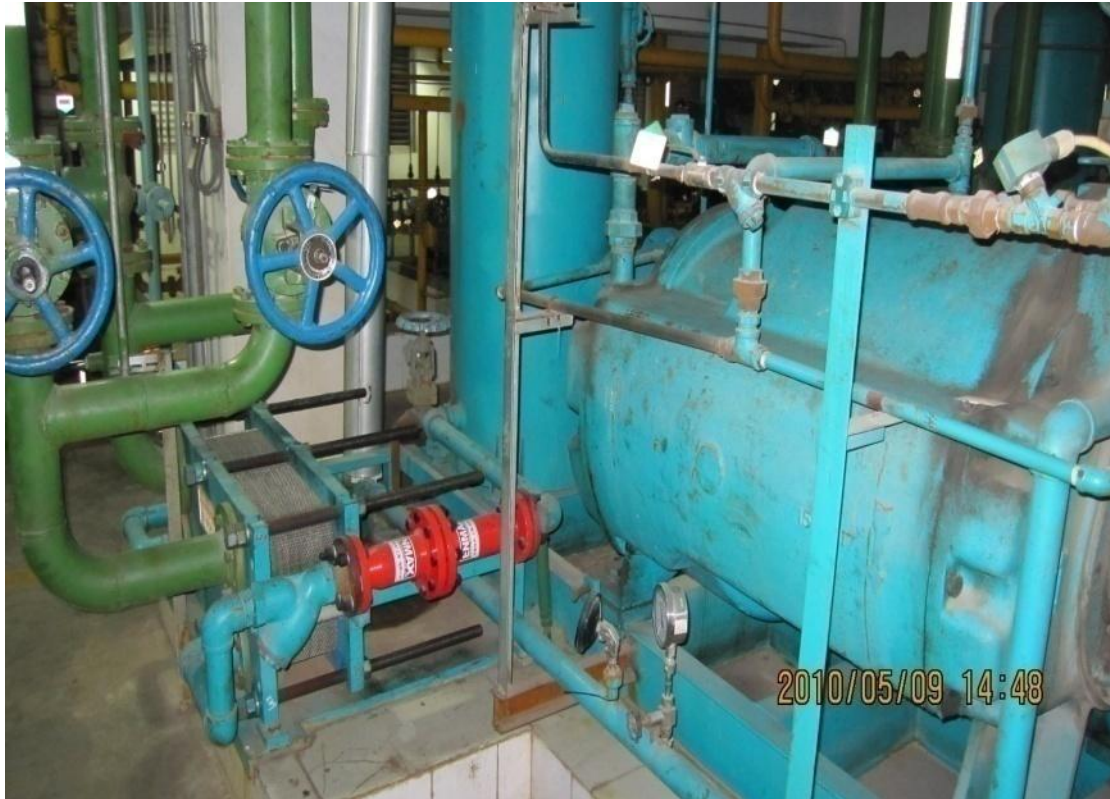
- The air separator cooling tower bundles are of #10 steel, and had not been treated for corrosion resistant.
- Since the cooling tower being put into operation in 2002, the bundle had a bad corrosion problem and the bundle surface had a layer of rust scale.

- Two months after the installation, the old rust scale came off and 1 cm of rust layer at the bottom of the cooling tower can be seen.
- The residual scale on the bundle surface became soft and loose and can be scraped off with fingers.
